Manhole Inspection Summary

Manhole # S17I__040MH

Insp Date: **7/31/09 2:12 PM**

Location Address: **40 S CATHERINE ST**

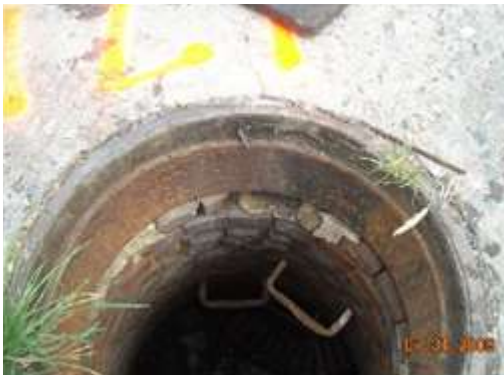
Defect 1

Frame Offset: **2** (in.) Condition: ☒ Sound ☐ Cracked ☐ Leaks

Chimney / Frame Adjustment ☒ Exists Material: **Brick** ☐ Parged Height: **5** (in.)
Condition: ☐ Sound ☐ Cracked ☐ Root Intrusion ☒ **Loose Brick** ☐ Deteriorated
Infiltration: ☒ None ☐ Joint ☐ Cracks ☐ Mortar ☐ Roots ☐ Wall

Steps Count: **4** Missing: **0** ☒ **Corroded**

frame offset; chimney has loose brick;
corroded steps

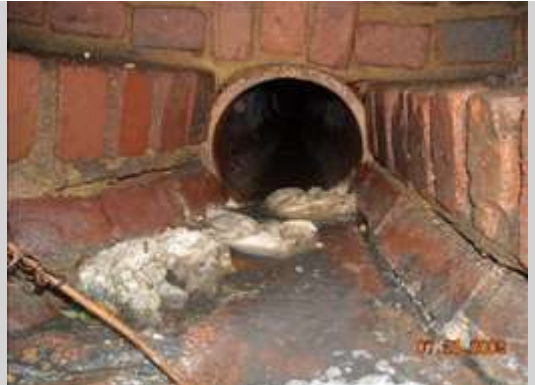
12 O'Clock Outflow

8 in. Circular Gravity Sewer
Pipe Out @ 12 O'Clock

Pipe Height: **8.4** (in.) Rod and Bar (Angled)
Pipe Material: **Clay** ☐ Pipe Lined
Invert Depth: **7.88** (ft.) Flow Characteristics: **Slow**
Deposits: ☒ None ☐ Mud ☐ Sludge ☐ Debris ☐ Grease
Silt Depth: **0** (in.) Deposits Extent:
Infiltration: **None** Pipe Seal Cond: **Sound**

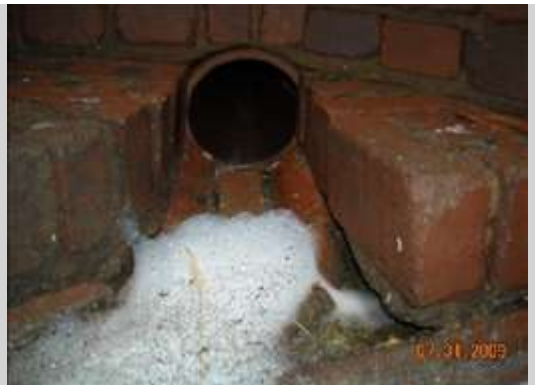
4 O'Clock Inflow

6 in. Circular Gravity Sewer
Pipe In @ 4 O'Clock

Pipe Height: **6** (in.) Rod and Bar (Angled)
Pipe Material: **Clay** ☐ Pipe Lined
Invert Depth: **7.66** (ft.) Flow Characteristics: **Slow**
Deposits: ☒ None ☐ Mud ☐ Sludge ☐ Debris ☐ Grease
Silt Depth: **0** (in.) Deposits Extent:
Infiltration: **None** Pipe Seal Cond: **Sound**

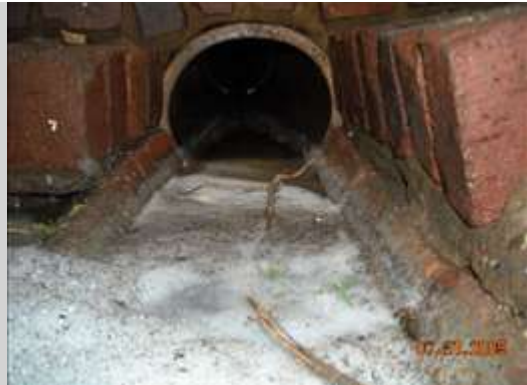
6 O'Clock Inflow

8 in. Circular Gravity Sewer

Pipe In @ 6 O'Clock

Infiltration: **None** Pipe Seal Cond: **Roots**

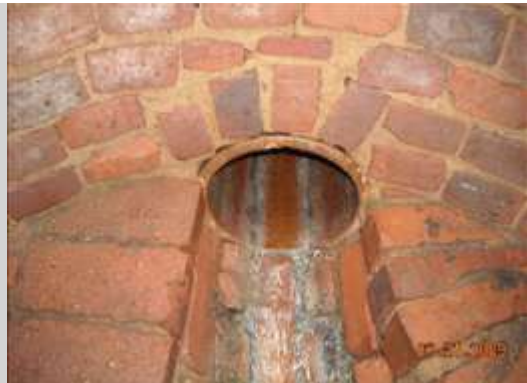
9 O'Clock Inflow

8 in. Circular Gravity Sewer

Pipe In @ 9 O'Clock

Infiltration: **None** Pipe Seal Cond: **Sound**
